NASA APOLLO PROGRAM WORKING PAPER NO. 1333

AN INVESTIGATION OF APOLLO TITANIUM PRESSURE VESSEL
WELDS MADE WITH COMMERCIAL PURE FILLER WIRE

MANNED SPACECRAFT CENTER
HOUSTON, TEXAS
January 1968

Glenn M. Ecord
AST, Materials Technology Branch

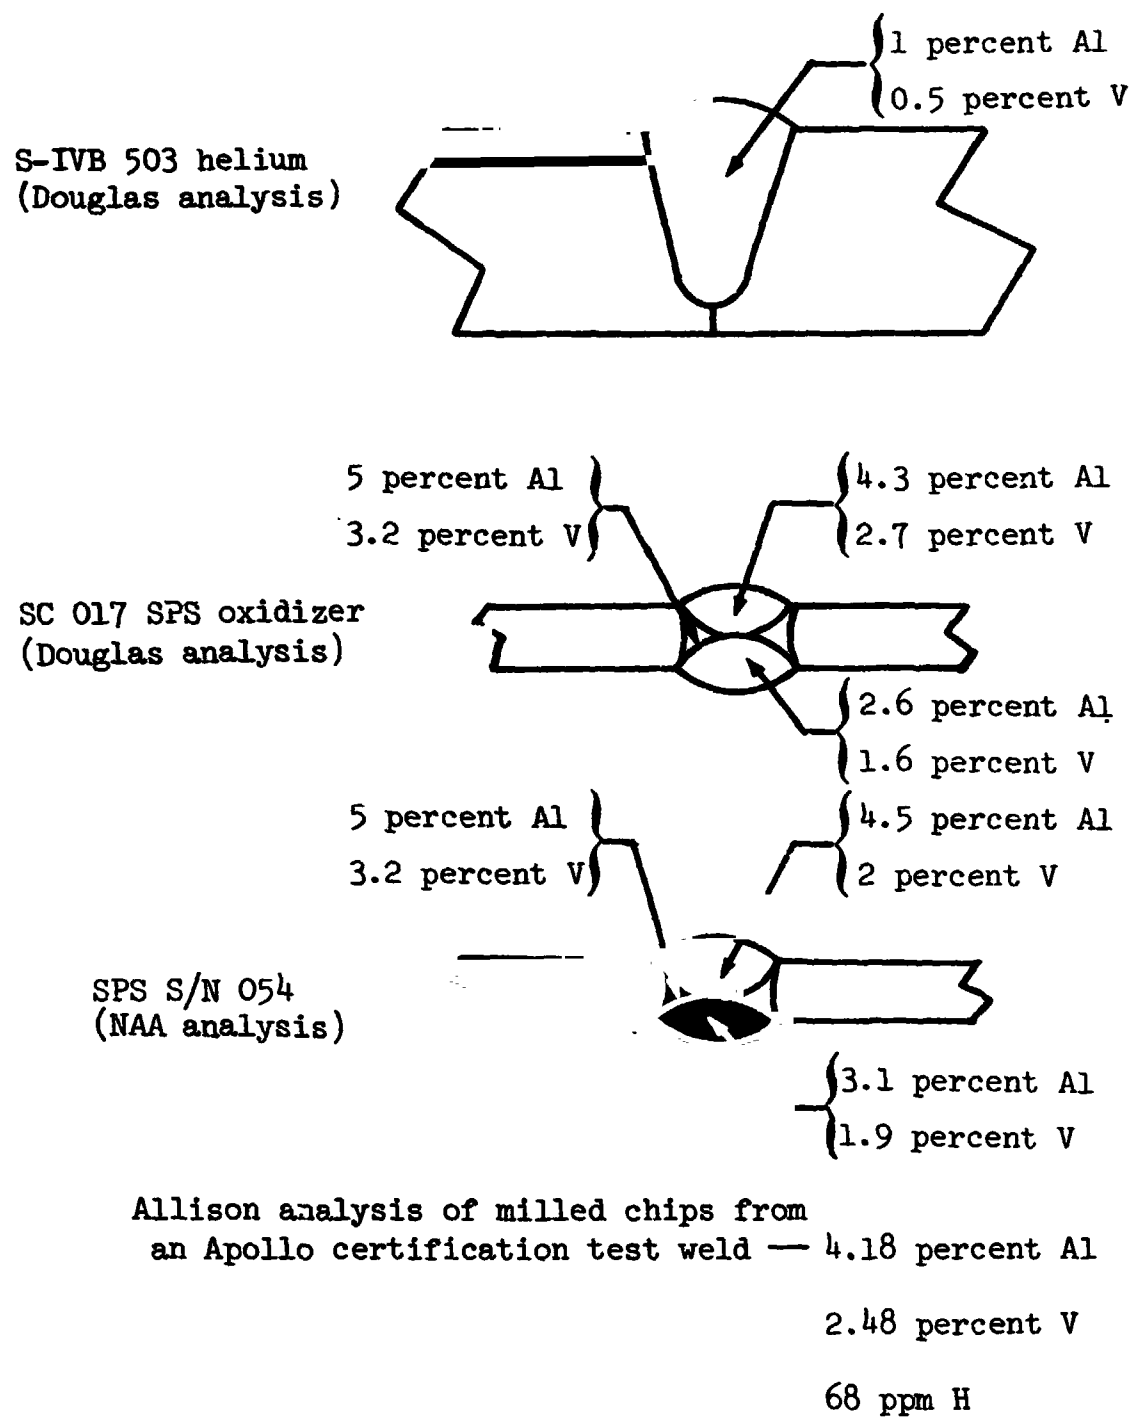
Figure 5.- Comparative chemical analyses of Apollo and Saturn welds.

Figure 5 illustrates the comparative chemical analysis of Apollo and Saturn welds. The alloy content of the Saturn weld drops sharply just inside the fusion line to approximately 1 percent aluminum as opposed to an average 6 percent aluminum in the parent metal. It is in this area that the hydride formation occurred in the Saturn weld. A hydrogen analysis made in the area of hydride formation showed the hydrogen content

to range between 600 and 1600 ppm. This high hydrogen content was present although the hydrogen content of the parent material, the weld bead, and the wire used in fabricating the Saturn welds was less than 70 ppm.

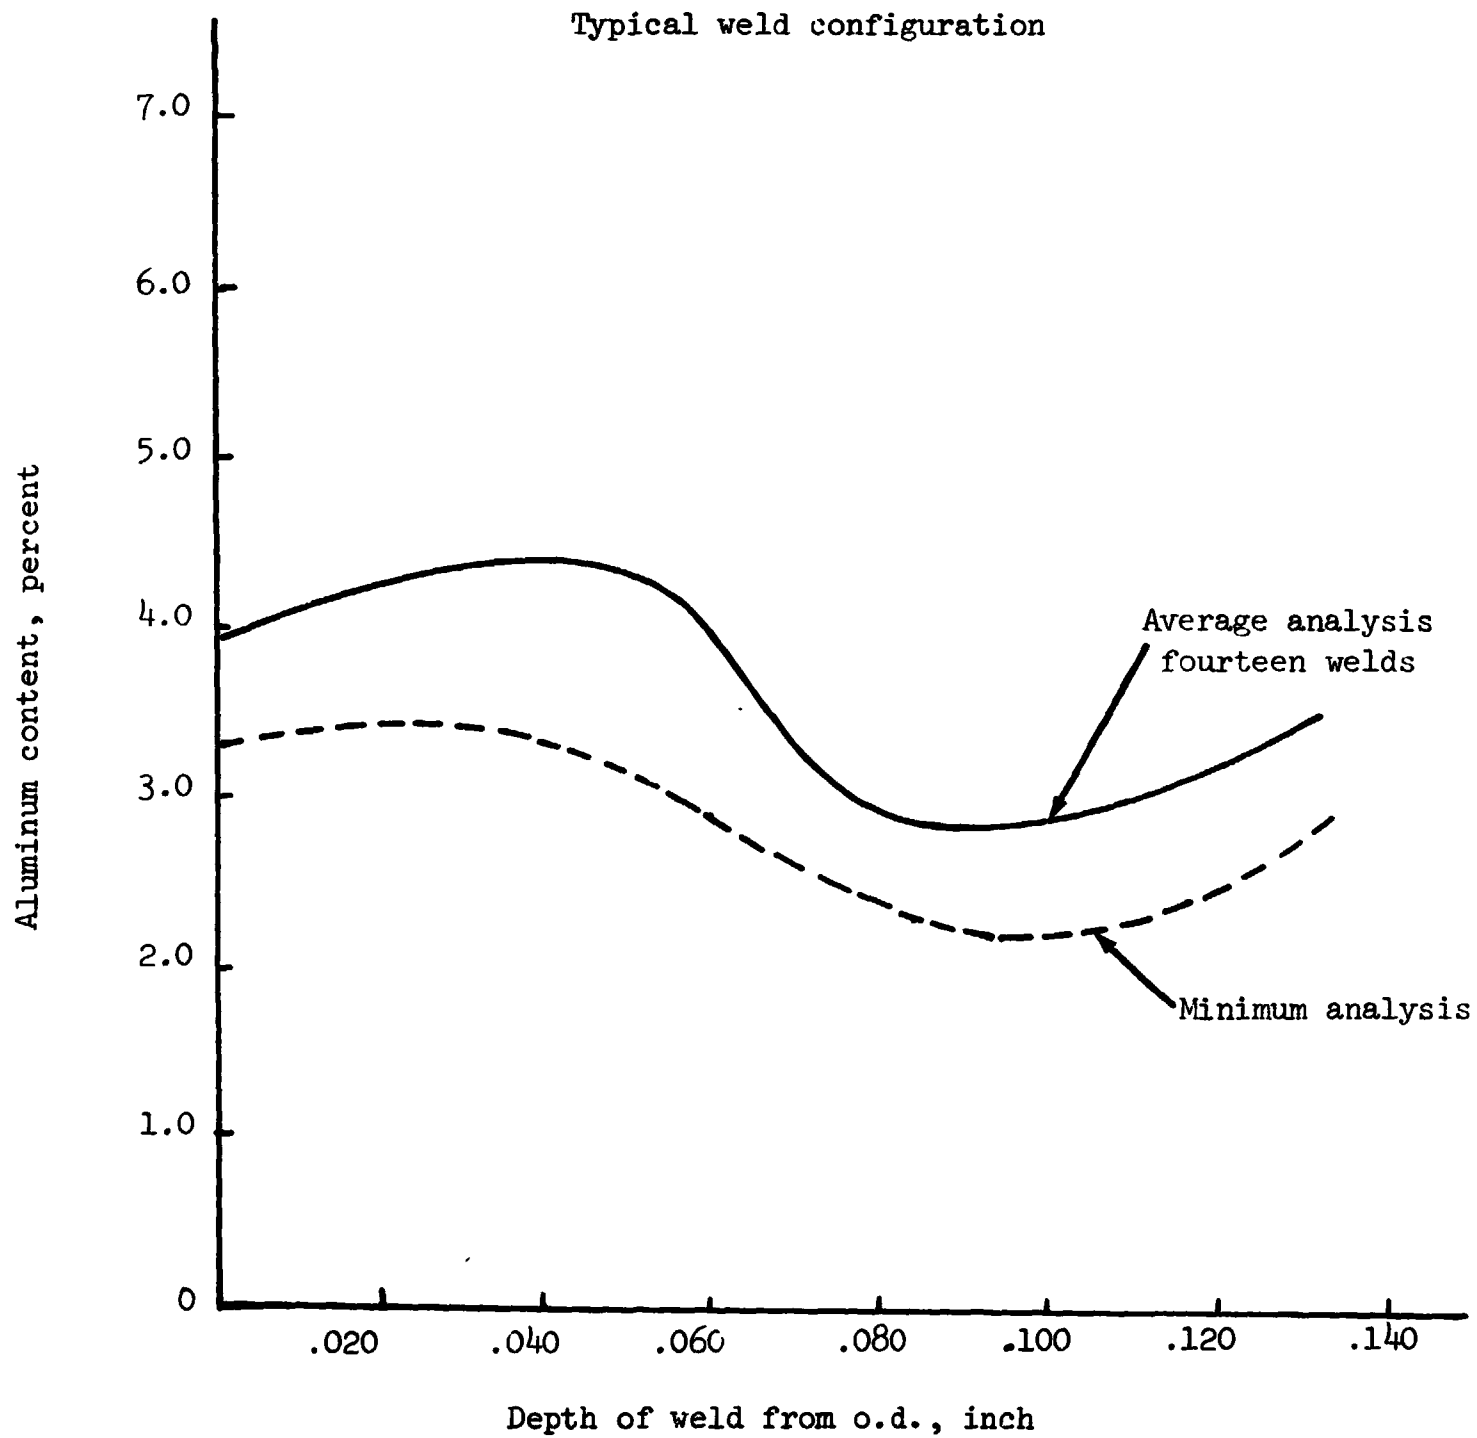
Figure 6.- Aluminum content of Apollo SM/SPS propellant vessel welds.

The average and the minimum analysis for 14 Apollo service propulsion system (SPS) propellant vessel welds are shown graphically in figure 6. It is noted that the analysis for any one of the welds did not go lower than 2 percent aluminum. Based on the 14 analyses, it was decided that 2 percent aluminum could be considered an arbitrary lower limit for aluminum content in Apollo welds. The lower limit was arbitrarily established because anything below this limit would be generally considered as abnormal for the Apollo weld.

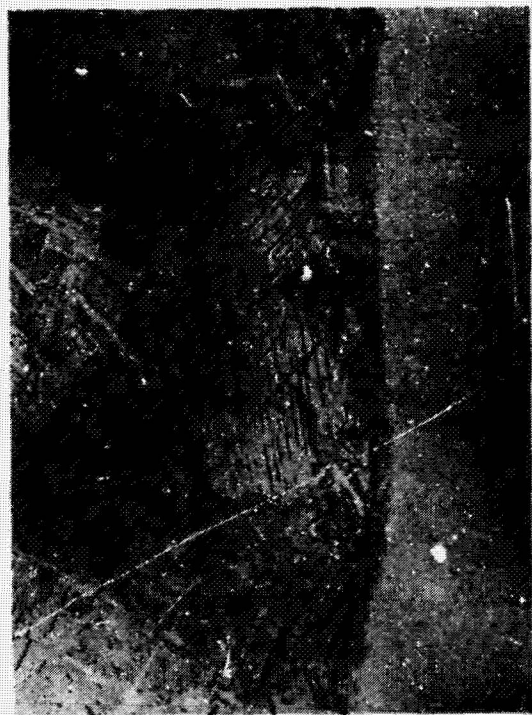
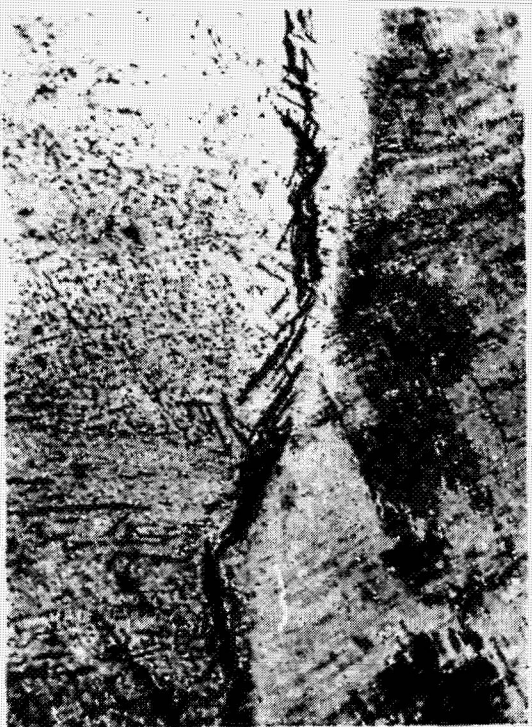
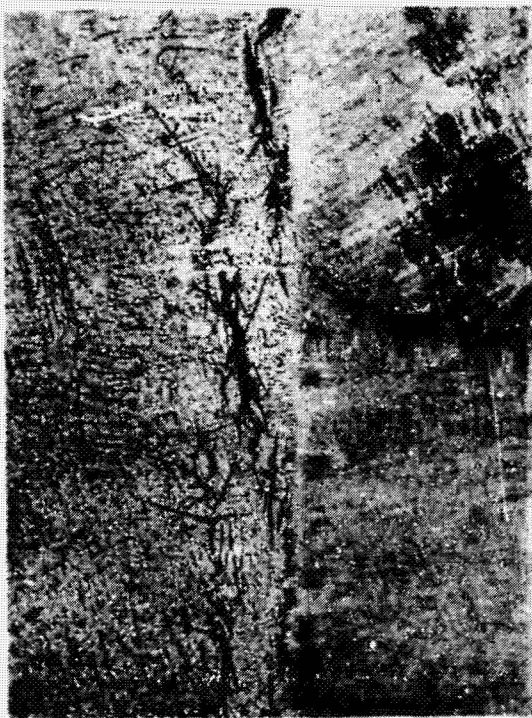
Metallographic examination revealed vessel fracture occurred through a semicontinuous phase (identified as titanium hydride). Besides metallographic appearance, two other methods were used to identify the hydrides. Filings from the fracture surface of the tank halves were collected as well as filings from the fracture surface of fragment no. 888. Vacuum fusion analysis of the collected filings at four different locations gave from 600 to 1600 parts per million hydrogen. The hydrides were also identified by electron diffraction techniques.

Figure 9.- Photomicrographs of Saturn weld (fragment 888) showing titanium hydride bands (X100).
Weld metal — parent metal fusion line.

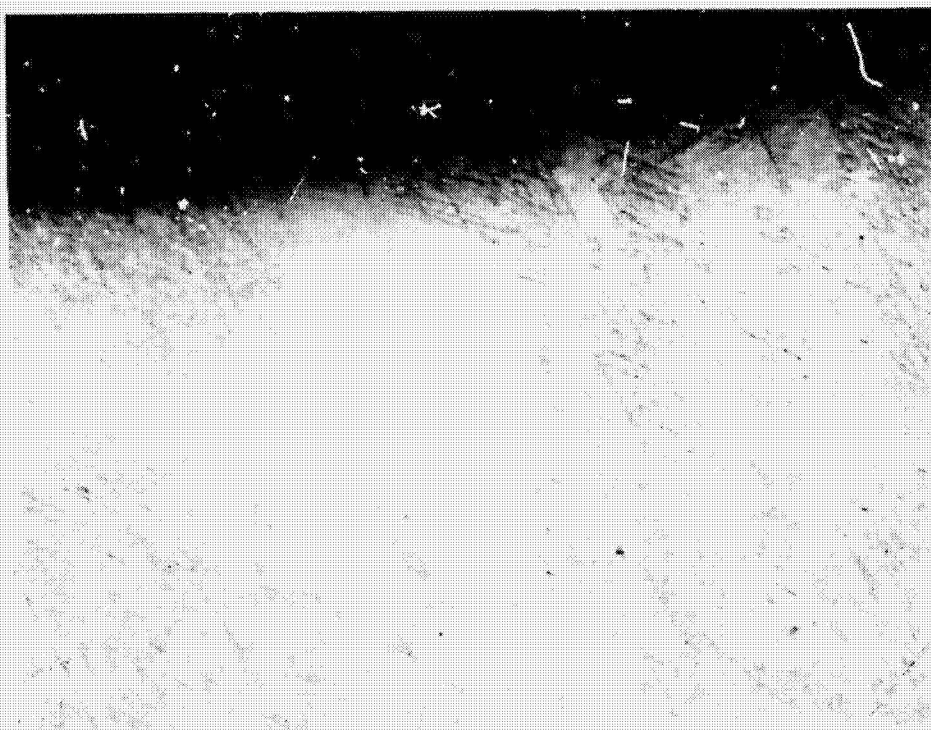
(a) SC 101 (fuel tank) G3 weld bottom (X150).

Figure 10.- Photomicrographs of typical Apollo welds made with CP weld wire. Weld metal — parent metal fusion line.

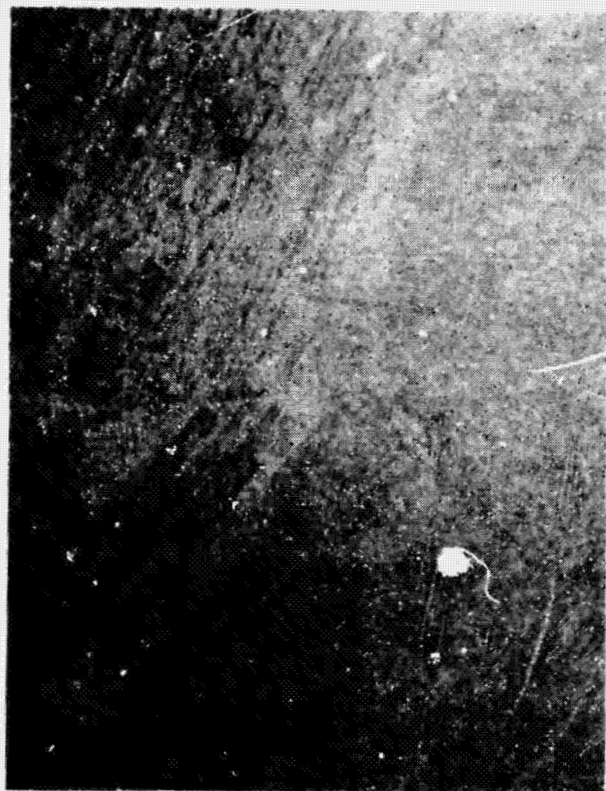
(a) G1 weld (top).

Figure 11.- Photomicrographs of welds from SC 017 fuel tank S/N 023 (X150). Weld metal — parent metal fusion line.

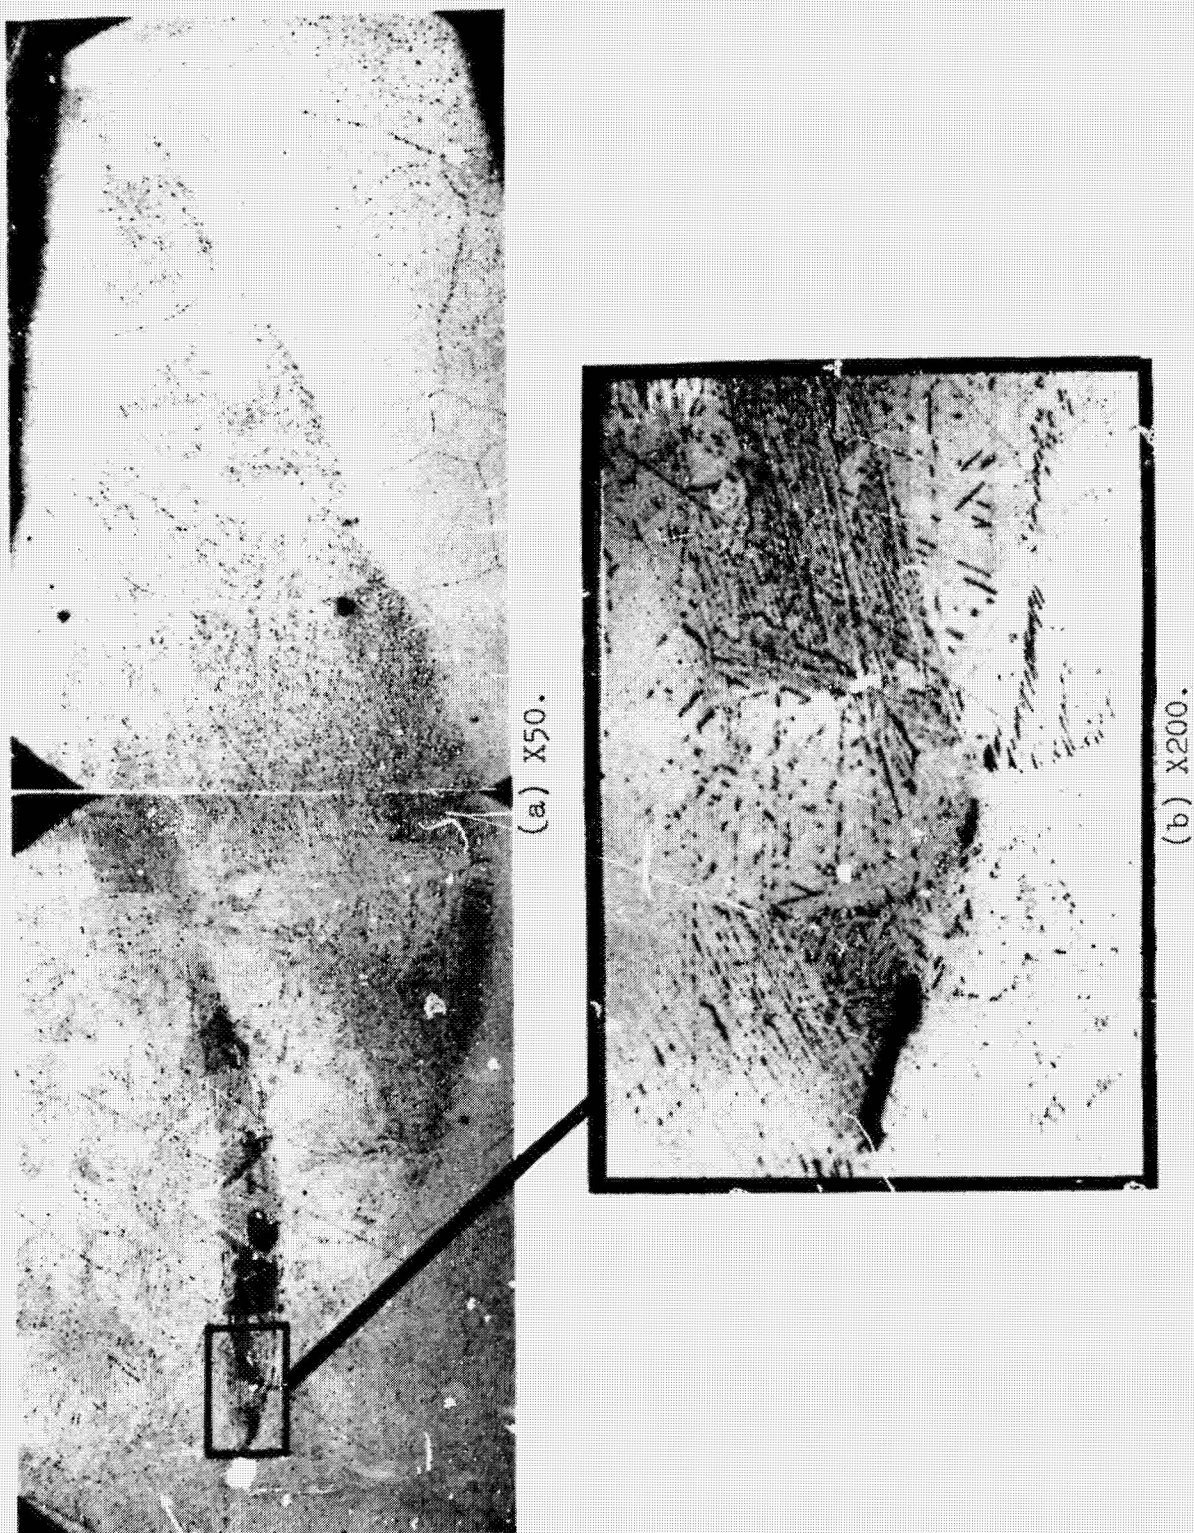
Figure 12.- Photomicrographs of an Apollo double method 2 weld repair, tank S/N 066.

A second significant difference in the welds is noted at the fusion line between weld metal and parent metal. The Saturn weld exhibits a very sharp, distinct fusion line while the Apollo welds do not. The absence of sharpness is indicative of the dissolution and higher alloy content in the Apollo welds. Figures 9, 10, and 11 show the Apollo and Saturn weld structures, respectively. Examination of the "worst case" Apollo weld repair (a double method 2 repair) where the alloy content would be expected to be the lowest, showed no banding or agglomeration of hydrides. One zone in the weld was analyzed to be nearly unalloyed titanium (see fig. 7, S/N 066) and contained a relatively large amount of small scattered titanium hydrides. Figure 12 shows the weld section. An enlargement of the low alloy portion is also shown which exhibits

indications of slight hydride banding and lack of fusion. The condition in no way approaches the severity of hydrides found in the Saturn weld.

It is concluded that Apollo welds made or repaired according to specification requirements are not affected by hydride agglomeration or banding. An exception is a double method 2 repair where the second repair was made off-center to the first. A zone of very low alloy content, less than 1 percent Al, was detected in this repair with evidence of slight hydride agglomeration within this zone. The necessity for a double repair of this type may indicate a serious process problem with the particular weld. For this reason and the fact that the double method 2 repair is a "worst case" repair, considering alloy content, vessels containing such repairs have been removed from use in the Apollo Program. It has been pointed out, however, that an Apollo propellant vessel with two welds repaired by combinations of methods resulting in a low alloy content* survived an 80-day sustained load test at maximum operating pressure and subsequently was burst above design burst pressure. Examination of the unrepaired and repaired welds from this vessel showed no hydride agglomeration or banding.

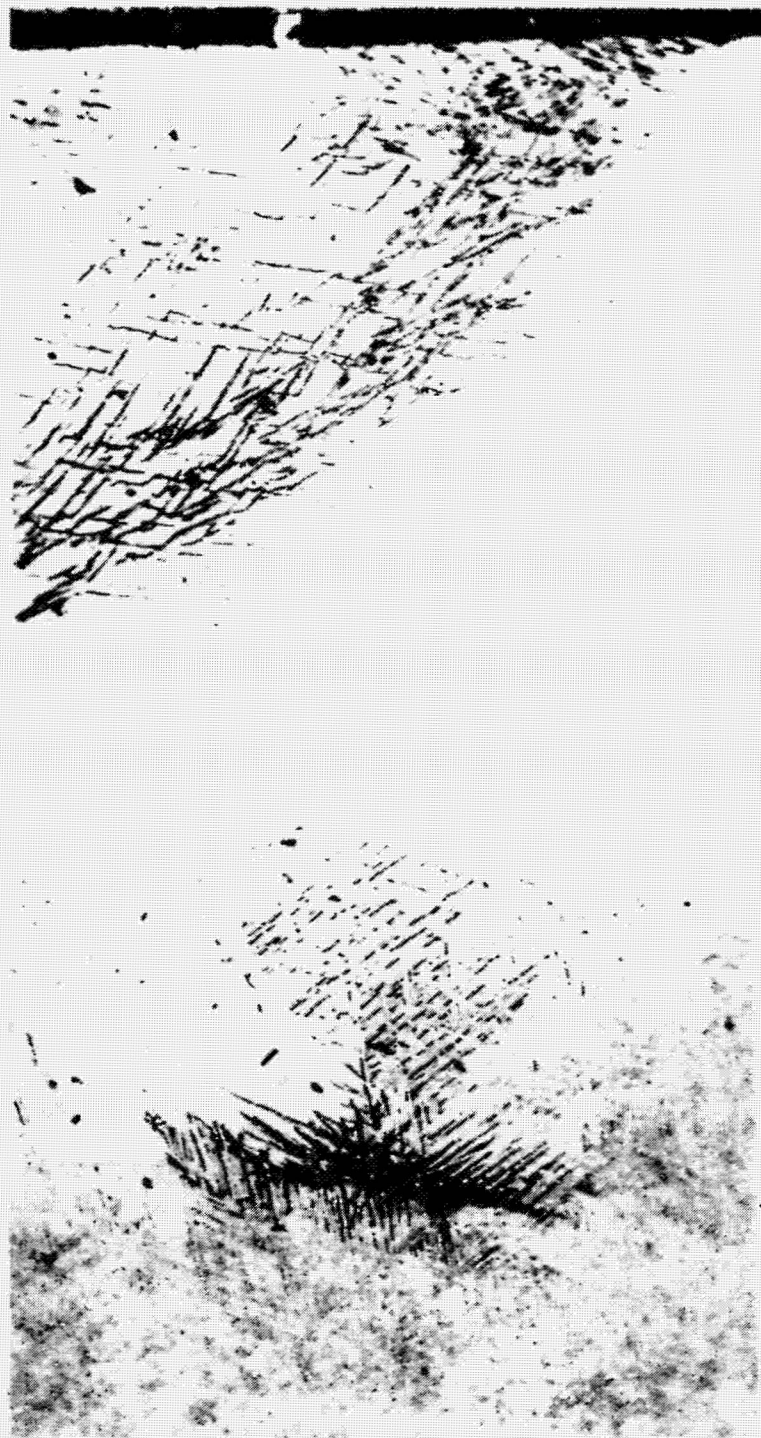
Figure 13.- Photomicrographs showing hydride agglomeration at a fusion line in an Apollo weld (X250).

During the course of this investigation, a problem with CP wire welds was experienced by an Apollo vendor. Metallographic examination revealed hydrides at the fusion zone of a weld repair as shown in figure 13. This condition closely resembles the banding discovered in the Saturn weld. Subsequent investigation disclosed that the affected welds had inadvertently been heat-treated in a hydrogen contaminated atmosphere. The hydrogen introduced externally had selectively precipitated at the fusion line area of the low alloy weld repair. Similar weld repairs not exposed to the hydrogen atmosphere heat-treatment did not exhibit hydride banding. Figure 14 shows the effect on an Apollo weld from introduction of hydrogen by electrochemical action.

NOTE: The weld repair is contaminated by a known hydrogen atmosphere.

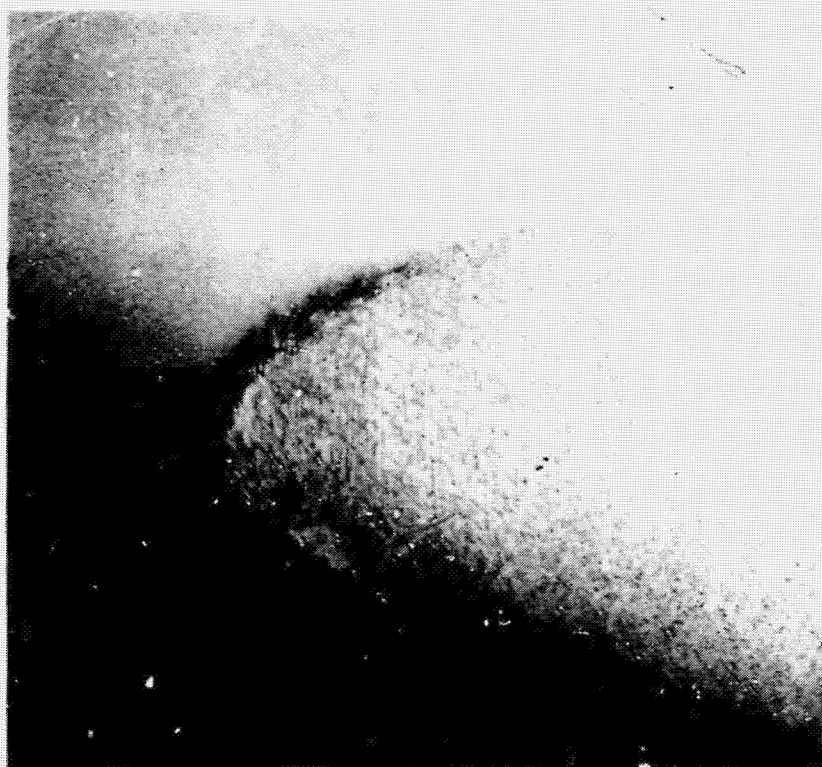
Figure 14.- Photomicrograph of an Apollo weld hydrogenated by electrochemical action (X150).

Attempts to reproduce the hydride banding in Saturn type CP welds have been generally unsuccessful. Some success has been experienced when hydrogen is externally introduced or when the welds are given a specific heat treatment. Attempts by SMD to produce hydride banding in Apollo welds by heat treatment or sustained stress were unsuccessful. When hydrogen was charged into the welds by an electrochemical process, hydride banding was observed at the weld-parent metal fusion line. During the course of the investigation, an Apollo vendor experienced a hydride problem in a pressure vessel welded with CP filler wire. The cause of the problem was traced to inadvertent heat-treatment of the vessel in a hydrogen-containing atmosphere. Titanium hydrides were observed banded at the weld-parent metal fusion line.
